# VR-001

## Vintage Radio Application Note

# RECONDITIONING AND MODERNIZING THE HEATHKIT HP-23 AC POWER SUPPLY

Rev A03/02-16/vr001\_apl\_01  
By Alex J. Burwasser, N6DC  
Original Writing: July 2011

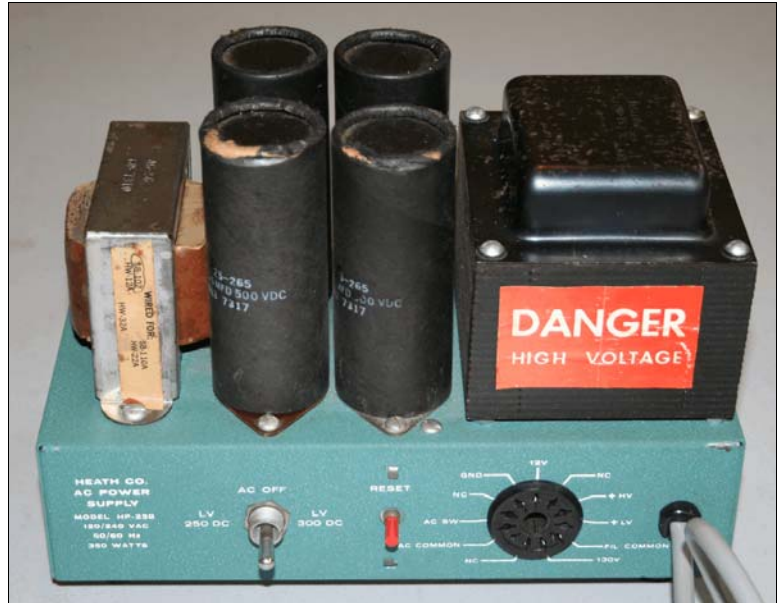
**Figure 2 - HP-23B w/Top Cover Removed**

As stated above, the HP-23B I procured on Ebay was functional and structurally sound, but somewhat shop-worn and very aged. Figures 2 and 3 illustrate the unit with its top and bottom covers removed.

C1-C4 are the tall 125 uF/500 V electrolytic capacitors visible on the HP-23B chassis top-side (see Figure 2). As per the schematic of Figure 1, C1/C2 are used in the high-voltage supply while C3/C4 are used in the low-voltage supply. Since the high-voltage supply imposes the most demanding requirements on these capacitors, we will focus primarily on C1/C2.

Figure 12 is a topside photo of this same unit (see Figure 2 shot prior to reconditioning for comparison). Note the replacement capacitors for C1-C4 and their mounts.

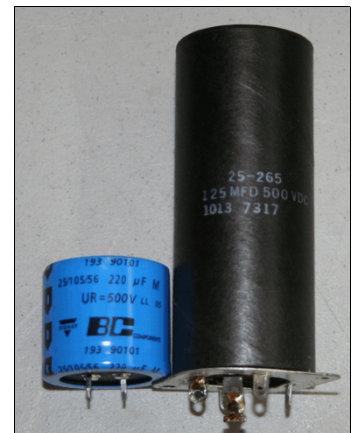
**Figure 6 - Electrolytic Capacitors - Then & Now**

Figure 6 is a photo of the modern 220 uF/500 V replacement capacitor (left) alongside the original 125 uF/500 V unit (right). This picture is worth a thousand words on the topic of improvements in electrolytic capacitor technology since the 1960s.

A vendor search to locate a 125 uF/500 V replacement electrolytic capacitor was unsuccessful. However, a premium grade 220 uF/500V manufactured by Vishay (P/N MAL219390101E3) was available from Digi-Key Corp. (P/N 4569PHBK-ND). The relevant specifications for this capacitor are as follows:

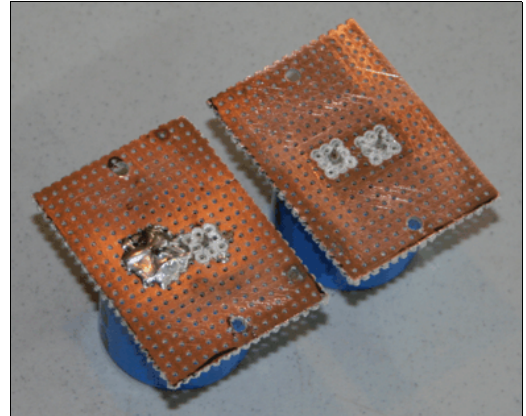
**Figure 7 - Capacitor Mounts (top)**

Although the 220  $\mu\text{F}/500\text{ V}$  capacitors selected to replace C1/C2/C3/C4 offer great performance and reliability, they did not fit the HP-23B chassis holes that were punched for these capacitors. It was thus necessary to fabricate capacitor mounts to handle this.

The most convenient available solution was to simply mount these capacitors on perforated prototyping boards as per Figures 7 and 8 and then mount these boards onto the chassis topside.

The perforated prototyping board material on-hand had holes drilled on a 0.1" grid and had copper-clad on one side. Since copper clad had to be cleared away from the non-grounded capacitor leads, it would have been better to have used board material with no copper clad on either side. The cut board dimensions are 2.2" x 1.6".

The capacitors employ a "snap-in" lead configuration. To accommodate this mounting configuration, board holes were drilled out with a #52 drill bit (slightly larger than 1/16") to provide a tight lead fit. The capacitors were mounted close to the center of the boards.

Additional holes were drilled at the ends of each board to accommodate the #6 mounting screws used to secure the original capacitor brackets to the matching chassis holes.
