# VR-002

## Vintage Radio Application Note

# RECONDITIONING AND MODERNIZING THE HEATHKIT HP-13 DC POWER SUPPLY

Rev A03/03-14/vr\_apl\_002  
By Alex J. Burwasser  
Original Writing: August 2011

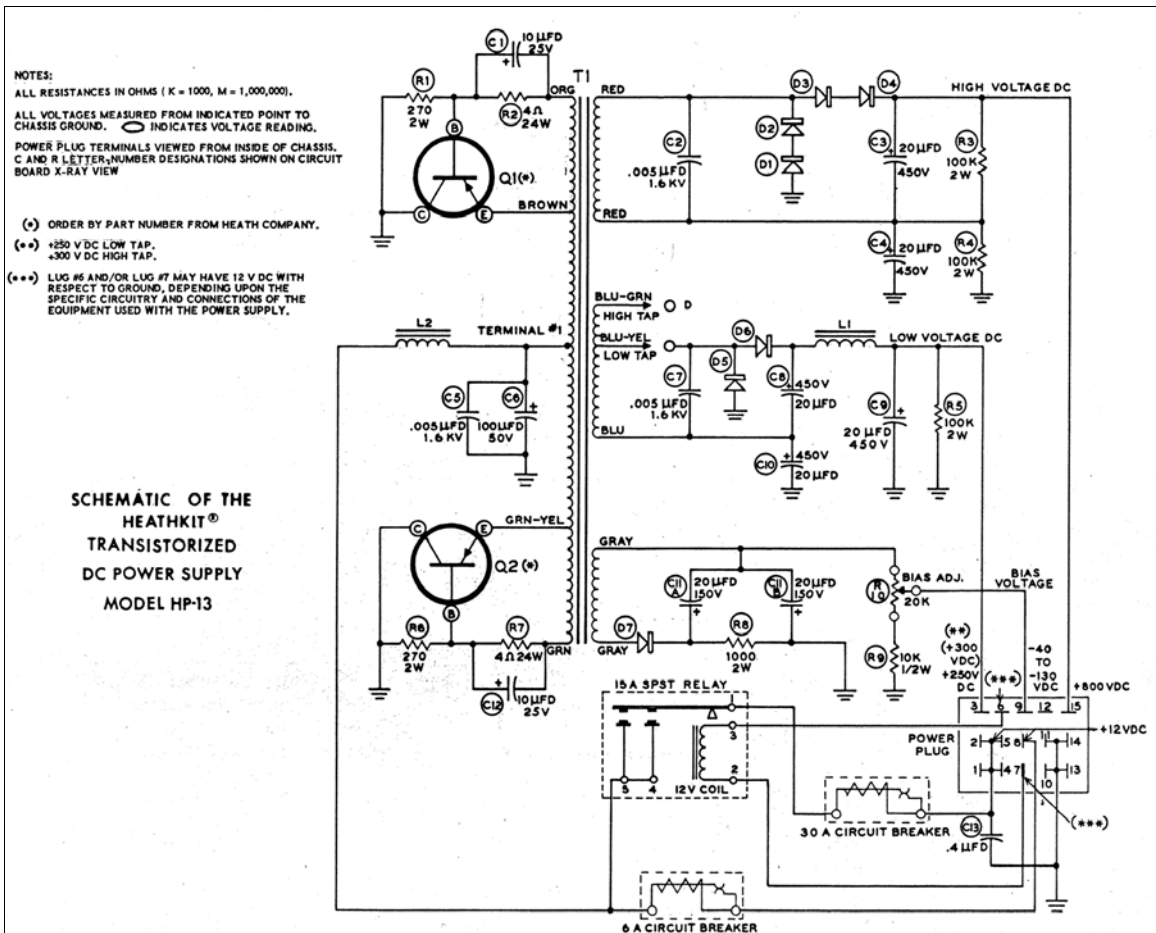
Figure 1 - Heathkit HP-13 DC Power Supply Schematic

Referring to the schematic of Figure 1, the HP-13 essentially is a transistorized inverter power supply that accepts +12 VDC (typically from an automotive electrical system), steps up the resulting AC voltage via a multi-secondary power transformer, and then rectifies and filters the various secondary voltages to obtain the desired DC outputs. The rated input voltage range is +12.0 to +14.5 VDC (negative ground). The rated maximum input current is 25 amperes at full load.

The HP-13 supplies three separate unregulated DC voltage outputs (in addition to a pass-thru +12 VDC filament voltage output). These DC output voltages are as follows:

High Voltage - The high voltage output is generated by a full-wave voltage doubler. Its rated output is +800 VDC no-load and +750 VDC @250 mA.

Low Voltage - The low voltage output is generated by a full-wave voltage doubler. Its rated output is +310 VDC no-load and +300 VDC @150 mA. This low voltage output can be reduced (for appropriate applications) by selecting the lower voltage tap on the T1 power transformer secondary. With the lower voltage tap selected, the rated output is +265 VDC no-load and +250 VDC @150 mA.

Bias Voltage - An adjustable bias voltage output is generated by a half-wave rectifier. This is a negative voltage rated at -40 to -130 VDC no-load, depending upon the setting of R10 (Bias Adj.). Current capacity is 20 mA at -130 VDC and 1 mA at -40 VDC.

Capacitive input filters are used for all three DC voltages. The low-voltage supply also employs an additional series filter choke (L1) followed by an additional shunt filter capacitor for improved AC ripple reduction.

The inverter switching frequency is nominally 1,500 Hz with loud audible ringing. Unlike modern inverters that employ switching frequencies above 20,000 Hz (and are inaudible as a result), inverters built back in the 1960s had to be designed using earlier generation power transistors that did not offer the enhanced high frequency performance available from modern power transistors. As a result, these inverters had to use much lower switching frequencies to operate efficiently.

The HP-13 rectifiers (D1-D7 from Figure 1) are all 1960s-vintage 1N2071 silicon diodes. These diodes are rated at 600 PIV (peak inverse voltage) with a maximum average forward current rating of 750 mA. Although these are old diodes, they are fully adequate for this application. Even so, being 40+ years old and with newer and better diodes available at very low cost, it seemed prudent to replace them.

As per the schematic of Figure 1, the full-wave voltage doubler employs series diode strings (D1/D2 and D3/D4) in each leg to increase the PIV ratings. To put some numbers on this, the required rectifier PIV rating for a full-wave voltage doubler is given by the following equation:

Again referring to the HP-13 schematic of Figure 1, the 800 volt open-circuit high-voltage is dropped across four rectifier diodes. If 470,000 ohm voltage equalizing resistors are placed across each diode, then the voltage across each 470,000 ohm resistor is  $800/4 = 200$  volts. The resulting power dissipation in each of these resistors can then be computed by Ohm’s Law as  $E \times E/R = 200 \times 200/470,000 = 0.085$  watts.

As per the schematic of Figure 1, C1 and C12 (both 10  $\mu$ F/25 V) are the inverter timing capacitors that are used to establish the 1,500 Hz (nominal) switching frequency. Although it was not clear to me what the ripple current requirements were for these capacitors, I decided to once again go with premium-grade replacements.

Referring to the schematic of Figure 1, C6 is a large bypass capacitor intended to hold the T1 inverter transformer center tap at AC ground. In conjunction with choke L2, it also serves to help filter inverter switching spikes from the +12 VDC input.

I strongly recommend adding this inexpensive part to the HP-13. Referring to the HP-13 schematic of Figure 1, the 1N5355B cathode be connected to the positive terminal of C6 (i.e., at the power transformer center tap) and the anode should be connected to ground.

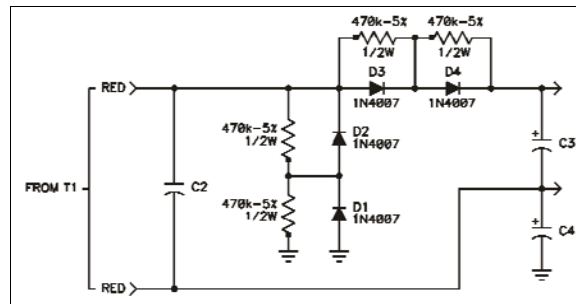
**Figure 2 - Full-Wave Voltage Doubler  
Modified to Include 1N4007 Silicon Diodes  
and Shunt Voltage Equalizing Resistors**

The issues associated with the highly variable back resistances of series diodes have been well-known for many years along with a mature and time-proven solution. Essentially, the remedy is to place shunt “swamping” resistors of the same value across each diode in the series string. If this resistor value is much lower than the diode back resistance, then the effective back resistance is essentially the value of this resistor and the voltage will divide nearly equally across each diode/resistor shunt pair.

where  $R_s$  is the required value of shunt resistance and PIV is the diode rated peak inverse voltage. Essentially then, the author recommends using 500 ohms of resistance per diode PIV rating. For a 1N4007 diode rated at 1,000 PIV, the required resistor value would be 500,000 ohms. A 470,000 ohm resistor is thus selected as a good-match standard value.

Purely from the standpoint of power dissipation, we could use 1/8 watt 5% carbon film resistors. However, resistors also have maximum voltage ratings and it would be unsafe to use a 1/8 watt resistor for this high-voltage application. 1/4 watt 5% carbon film resistors have a rated maximum working voltage of 250 VDC which would probably be adequate. However, it is better to use 1/2 watt 5% carbon film resistors with their higher rated maximum working voltage of 350 VDC. The modified diode section of the full-wave voltage doubler is illustrated in Figure 2.

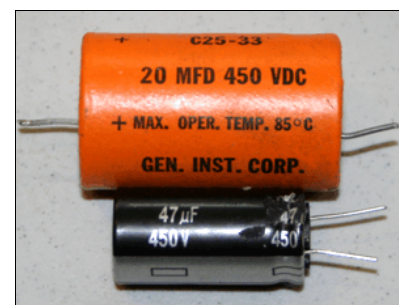
**Figure 3 - Electrolytic Capacitors - Then & Now**

Figure 3 is a photo of the modern 47  $\mu$ F/450 V Panasonic replacement capacitor (bottom) along with the original 20  $\mu$ F/450 V General Instrument Corp. unit (top). This picture is worth a thousand words on the topic of improvements in electrolytic capacitor technology since the 1960s.

A vendor search to locate a 20 uF/450 V replacement electrolytic capacitor was unsuccessful. However, a premium-grade 47 uF/450 V manufactured by Panasonic (P/N EEU-EE2W470) was available from Digi-Key Corp. (P/N 13677-ND). The relevant specifications for this capacitor are as follows:

Temperature Range:	-25°C to +105°C
Rated ESR @ 120 Hz:	6.77 ohms
Rated Ripple Current (120 Hz/105°C):	1.2 amperes

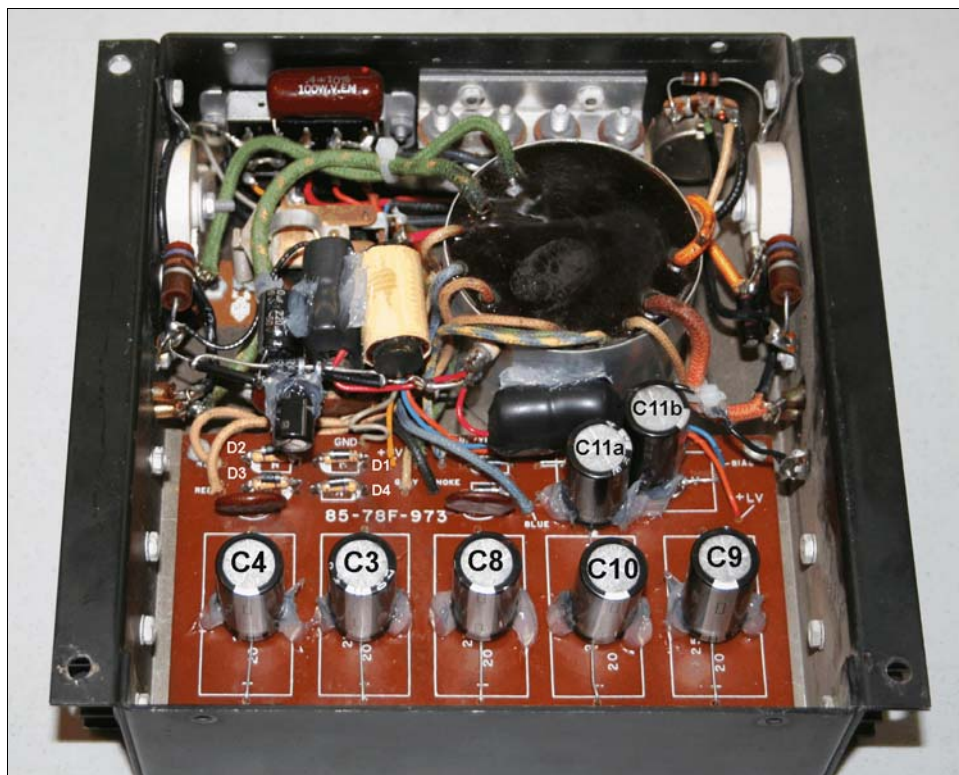
**Figure 4 - Chassis Photo  
(C3/C4/C8/C9/C10/C11a/C11b & D1-D4 replacements annotated)**

Figure 4 is a photo showing D1-D4 (all 1N4007s) mounted piggy-back on their associated 470k 1/2W equalizing resistors (located behind C3 and C4).

Although the 47 uF/450 V capacitors selected to replace C3/C4/C8/C9/C10 offer great performance and reliability, they did not fit the HP-13 PC board patterns that were made for these capacitors. While the replacement capacitors are much smaller than the originals, the bigger problem is that they are radial lead units (whereas the originals are axial lead units). Since modern capacitors are designed mostly for PC board mounting, it is increasingly difficult to find axial lead capacitors.

Since these capacitors are small enough to be mounted upright, I mounted them as pictured in Figure 4. Although the capacitor leads were long enough to reach the original component PC board mounting holes, these capacitors were not well-secured to the board using this unorthodox mounting technique.

To correct this issue, I staked these capacitors down to the board using RTV (RTV is a form of silicone sealant). I used Permatex Part 66B (which is non-corrosive and available in many hardware and auto supply stores), but many other types are equally suitable. After allowing several hours to cure, the RTV secured these capacitors firmly to the PC board.

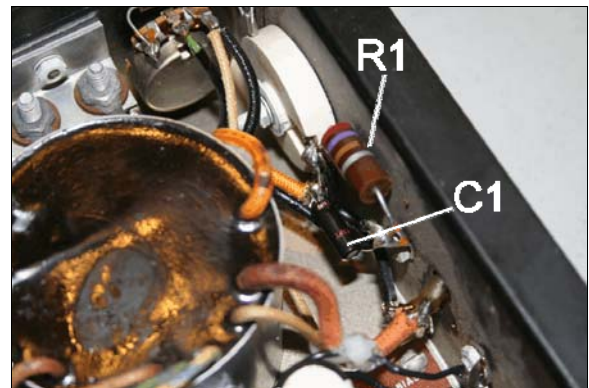
**Figure 5 - Replacement Timing Capacitor C1**

I selected 10  $\mu$ F/63 V capacitors manufactured by Panasonic (P/N EEU-EB1J100) and available from Digi-Key Corp. (P/N P13138-ND). As expected, these capacitors are much smaller than the original units. C1 is shown in Figure 5 (just below 270 ohm resistor R1). I staked-down both C1 and C12 with RTV.

Although the nominal inverter switching frequency is 1,500 Hz, the actual measured switching frequency with the original C1/C12 capacitors was near 1,600 Hz. This frequency rose slightly to near 1,700 Hz with the replacement capacitors.

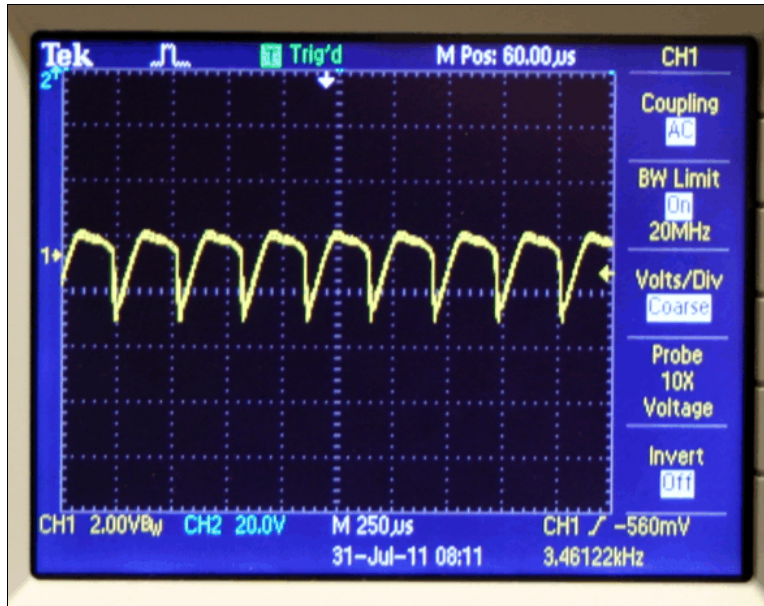
**Figure 6 - Voltage Across C6 (220 uF)**

Since there was no question in my mind that C6 needed to be a high-quality capacitor, I selected a premium-grade 220  $\mu$ F/50 V unit manufactured by Panasonic (P/N EEU-EB1H221) and available from Digi-Key Corp. (P/N P13131-ND). To my surprise, however, this capacitor became very warm to the touch when the power supply was powered-up. Probing this replacement capacitor with an oscilloscope, the voltage across it appeared as in Figure 6 (no load on power supply).

As per this photo, the magnitude of the switching spikes is 3 VPP, which is very large for a +12 VDC input. Clearly, the large ripple current resulting from these spikes was responsible for the capacitor overheating.

To improve things, two additional 220 uF/50 V capacitors were added in parallel with C6 (for a total of 660 uF). The result of this additional capacitance is shown in Figure 7.

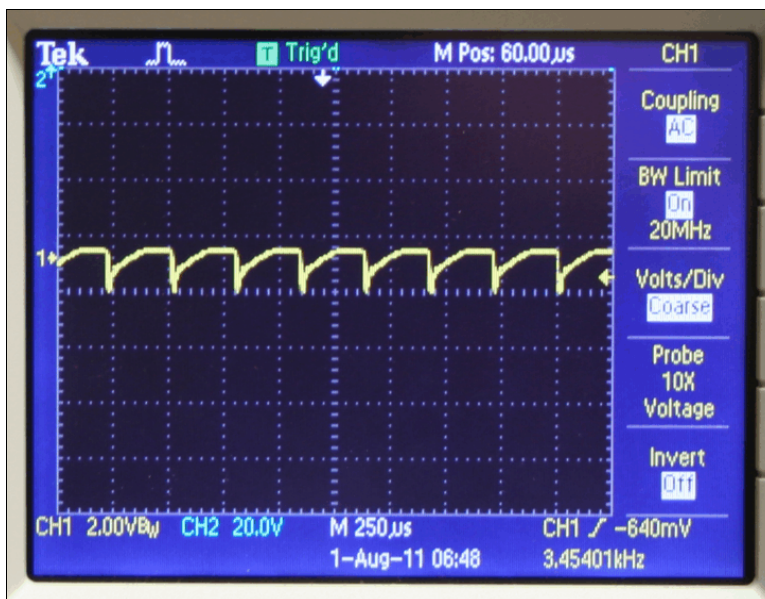
**Figure 7 - Voltage Across C6 (660 uF total)**

As per this photo, including the additional 440 uF of capacitance cut the switching spike magnitude in half to approximately 1.5 VPP. Also, the additional capacitance eliminated the heating problem as a result of the fact that this additional capacitance reduced ripple voltage and distributed the lesser resulting ripple current through three (rather than one) capacitors.

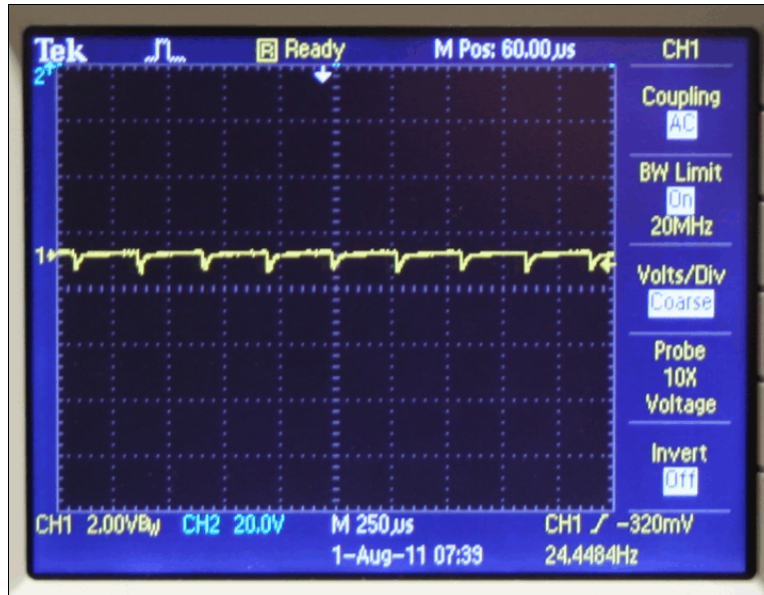
**Figure 8 - Voltage Across C6 (4,420 uF total)**

Although this was a significant improvement, it seemed that this ripple magnitude was still high (especially considering the fact that there was no load on the power supply). Also, it seemed that further improvement would require a large amount of additional capacitance. My next step then was to add eight 470 uF/25 V capacitors in parallel with the three 220 uF/50 V units already in place. With this very large amount of capacitance, the ripple voltage significantly diminished as illustrated in Figure 8.

With the benefit of hindsight, however, it is clear that this piecemeal and incremental approach leaves much to be desired. Subsequent to the photo shoot for Figure 4, these capacitors were all removed and replaced by a single 4,700 uF/35V electrolytic capacitor suitable for this application. This capacitor is manufactured by Panasonic (P/N ECA1VHG472) and available from Digi-Key Corp. (P/N P5558-ND). This unit has a very high ripple current rating (1.91 amperes).

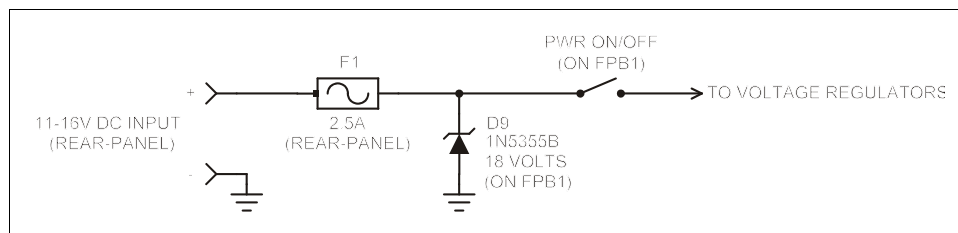
**Figure 9 - Over-Voltage and Reverse Polarity Protection Circuitry**

An apparent HP-13 design shortcoming is that it has neither over-voltage nor reverse-polarity protection at its 12 VDC input. This was remedied by adding a single Zener protection diode.

The operation of this protection diode can best be explained by examining an actual circuit where it has been successfully employed. Figure 9 is a simplified schematic of the input power circuitry of the RDF Products DFP-1000A DF bearing processor (the predecessor to the current DFP-1000B). The following detailed explanation of this circuit is an excerpt (with some minor paraphrasing) from the DFP-1000A Service manual:

*In cases where over-voltage is applied, however, it has been our experience that D9's junction typically fuses before the 2.5 ampere fuse blows (although it is possible that D9 can survive if the external power source has a sufficiently low current-limiting threshold), resulting in both a blown fuse and D9 presenting a direct short circuit as a result of its fused junction. In this case, it is necessary to replace both the 2.5 ampere fuse and D9. Even so, the input power protection circuitry has still functioned effectively, preventing major DFP-1000A damage at the expense of requiring replacement of only two inexpensive components."*

Since the HP-13 12 VDC input circuitry is protected by a 30 ampere circuit breaker rather than the faster acting 2.5 ampere fuse employed in the DFP-1000A, it is probable that the 1N5355B Zener diode would not survive the application of reverse-polarity power. Even so, this inexpensive and readily replaceable part would still protect the HP-13 power transformer and power transistors (parts that would likely be irreplaceable or very hard to find at best).
